UNITED STATES DEPARTMENT OF AGRICULTURE
SOIL CONSERVATION SERVICE
ROBERT M. SALTER, CHIEF
NORTHEASTERN REGION
AUSTIN L. PATRICK, REGIONAL DIRECTOR

REPORT
— ON —
SEDIMENTATION
— IN —
CARNEGIE LAKE

Princeton, New Jersey

SCS-TP-109
Upper Darby, Pa.
March, 1952

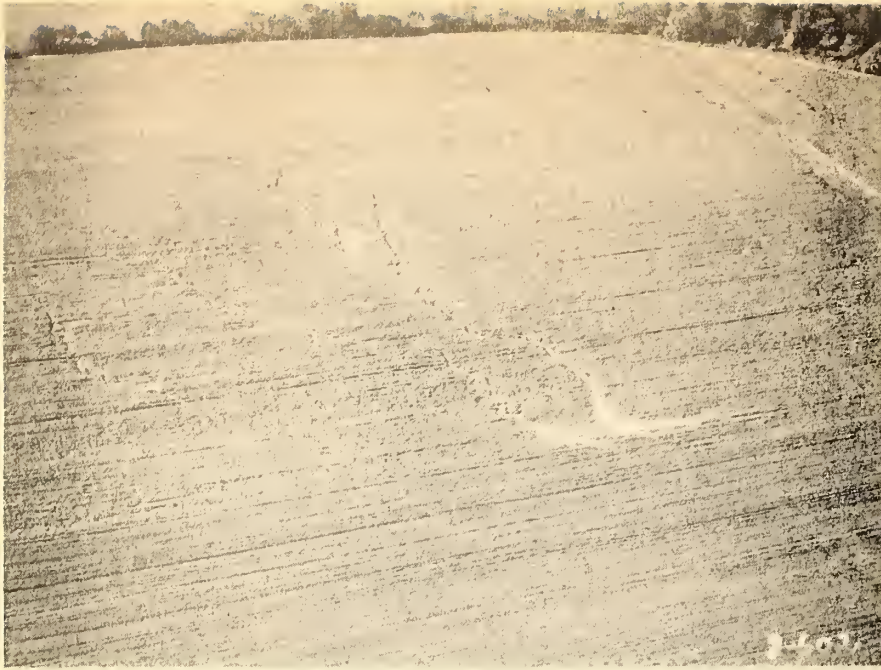
Heavy rains caused severe sheet and gully erosion west of Quaker Road and Old Princeton Pike.

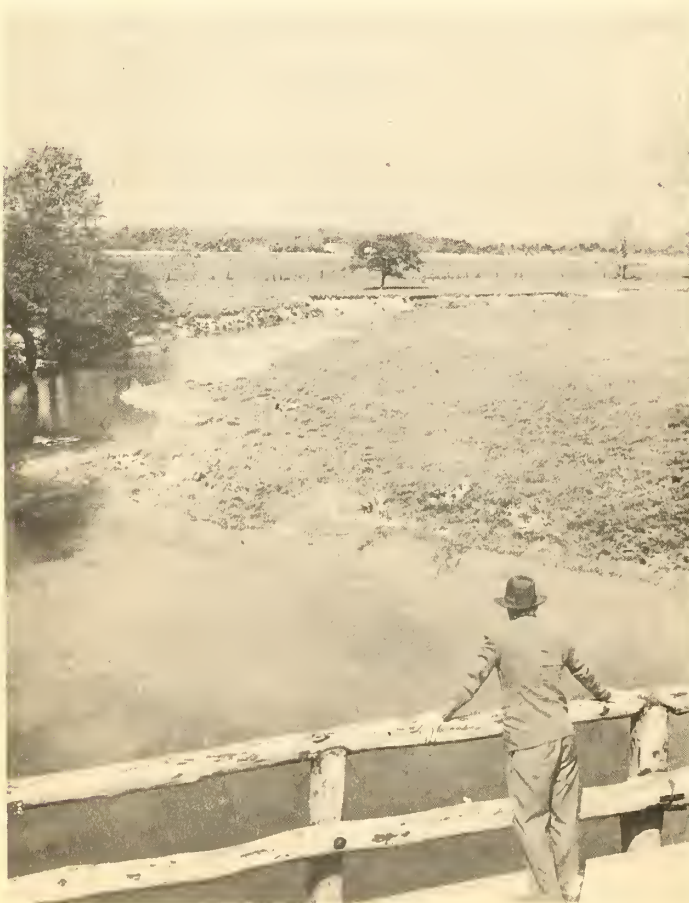
Severe streambank erosion along Stony Brook near Pennington, New Jersey

A detailed survey of the main channel of Stony Brook and sample surveys on its tributaries showed that streambank erosion is occurring at variable rates in different parts of the watershed. In forested areas rates are low enough to be almost negligible. In pasture, however, erosion is considerably accelerated by the trampling of cattle enroute to the water. The most se-

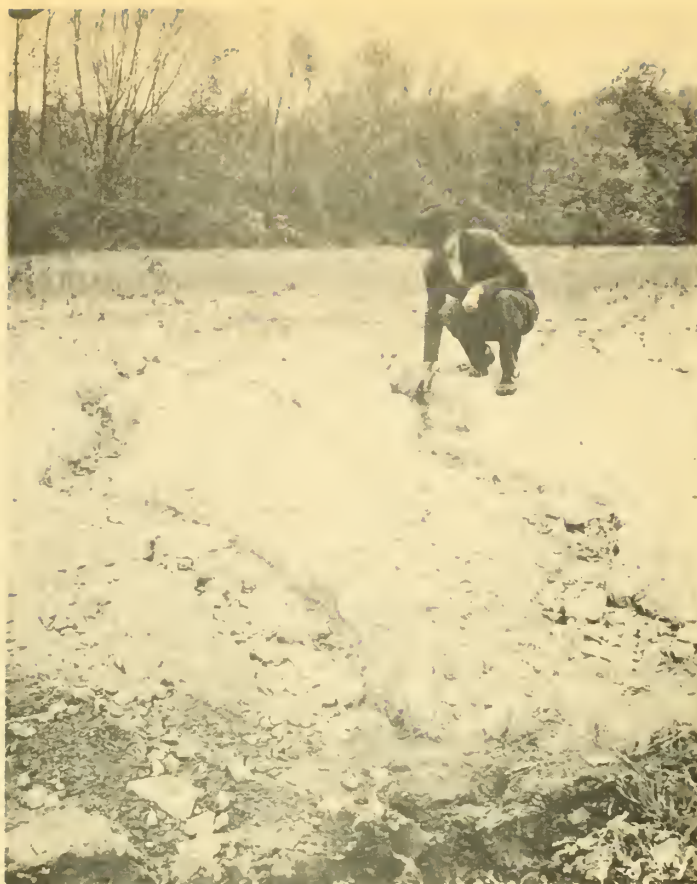
Roadbank erosion along Centerville road, Mount Rose,
New Jersey

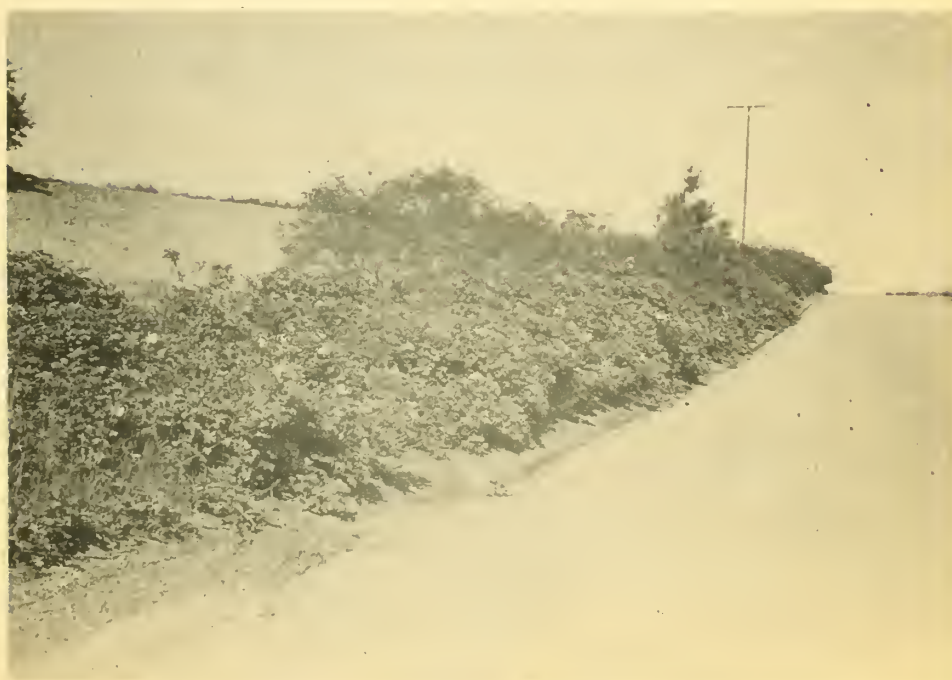
Roadbank stabilized by revegetation

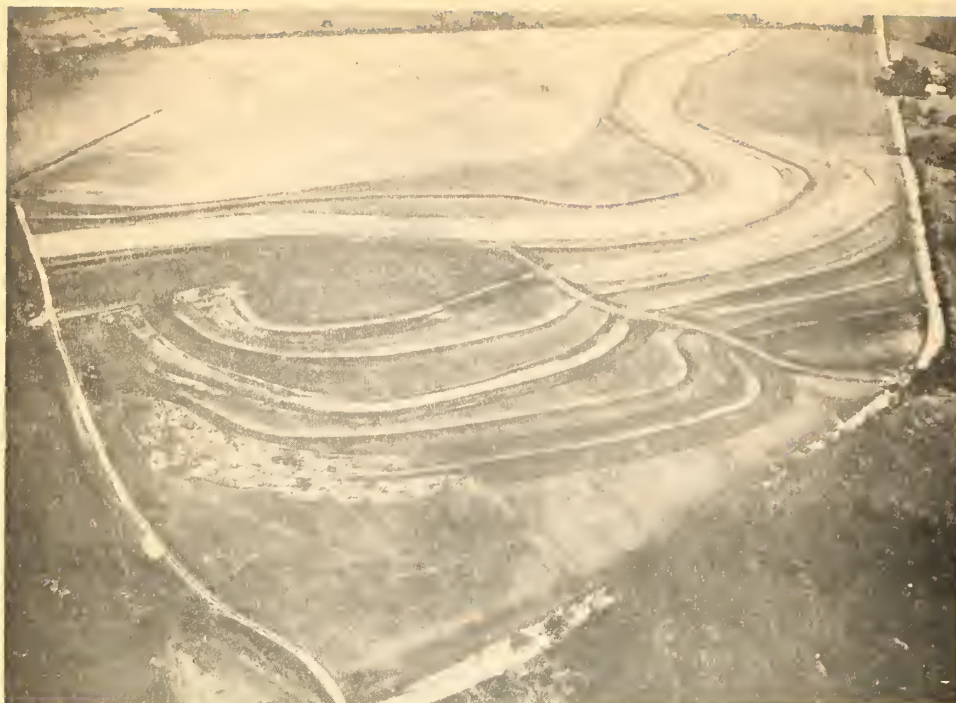
Grassed waterways carry water away safely and prevent gullying.
